ROYAL COMMISSION
QUEBEC BRIDGE INQUIRY
1907

VOL. II.

MINUTES OF PROCEEDINGS

PRINTED EXHIBITS

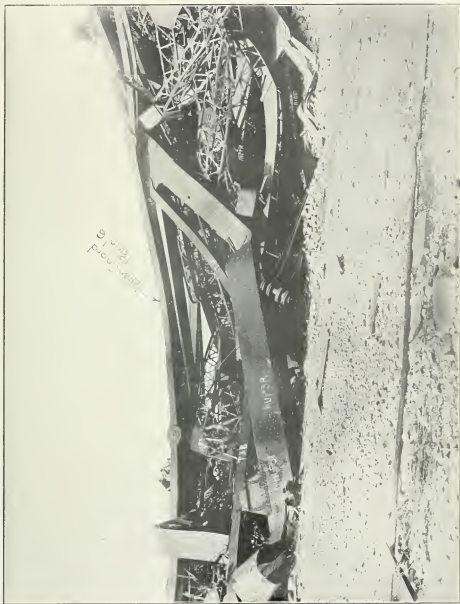
4. View of the same from a further distance. Note the distortions of ALP3R.

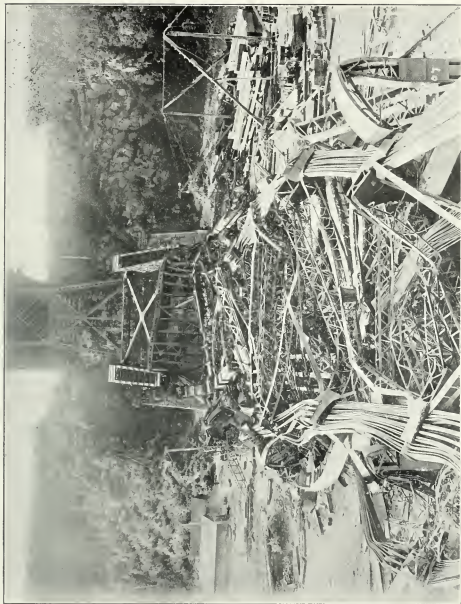
20. General view from the main pier southwards. Note the moderate damage to the upper laterals.

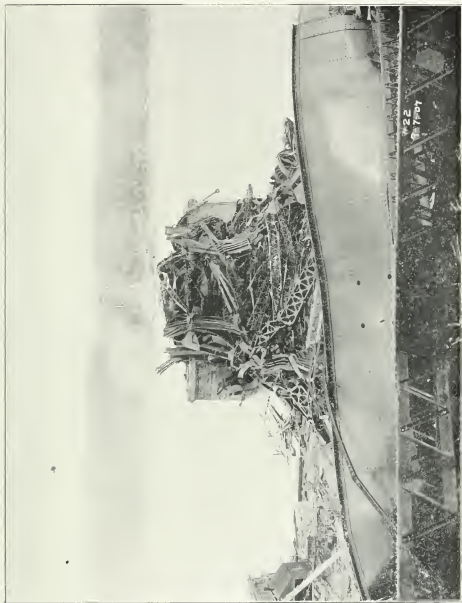
22. General view from the anchor pier northwards. Note the position of the wreckage on the main pier.

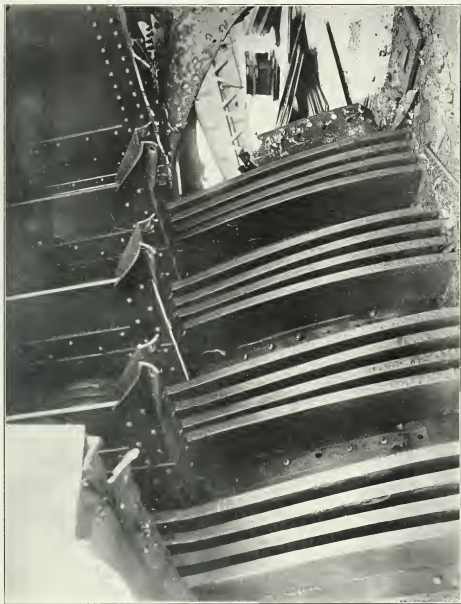
25. View of the anchorage of the right truss. Note the bendings of the anchorage bars; the scaling of the metal in them, and the folding and scaling of the tower shell.

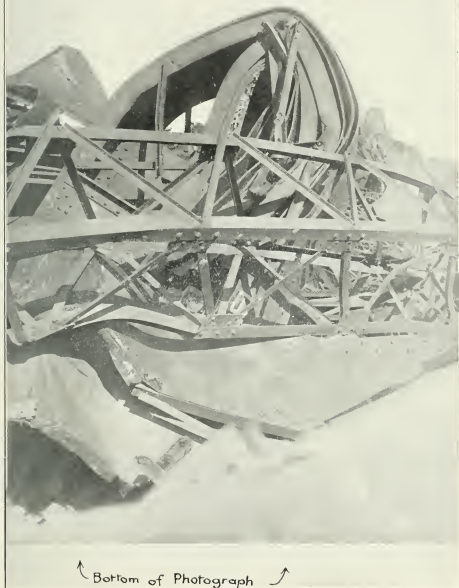
#2

2. Shows buckling of a post having two laminated webs latticed with angles. The four-angle strut in the foreground is part of the lateral system.

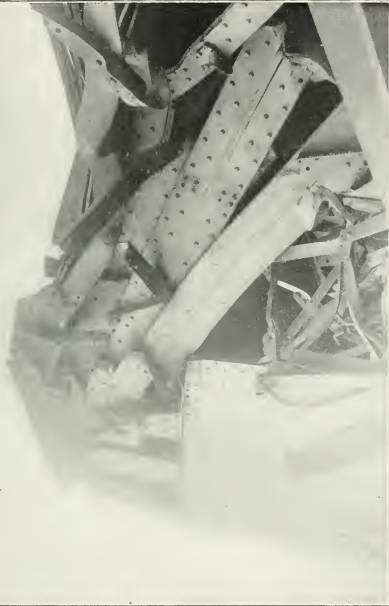
#4

4. Shows buckling of centre post CP4R. Note also the straight lines retained by the cover plates. The centre post generally was of the same design as lower chords, being composed of four parallel webs with the addition of extra flange angles.

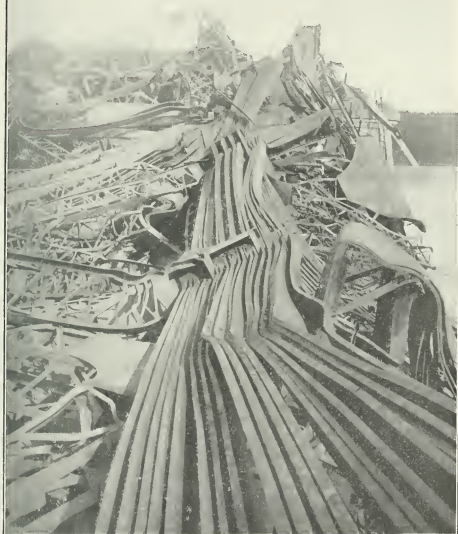
6

6. Shows the unbroken chain of eye-bars of the top chord of the Quebec side designated on the plans as AdR, AeR and AFR.

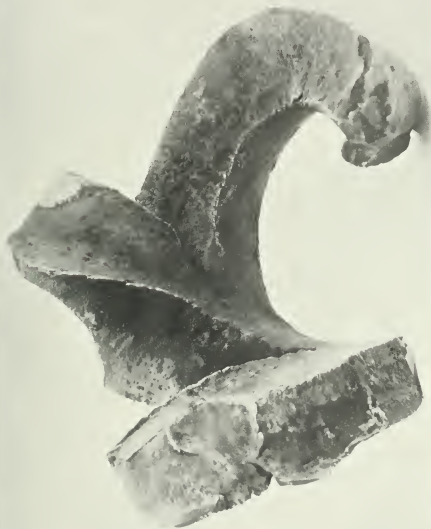
15

15. Shows a fragment of $\frac{3}{4}$ " plate torn, sheared and bent.

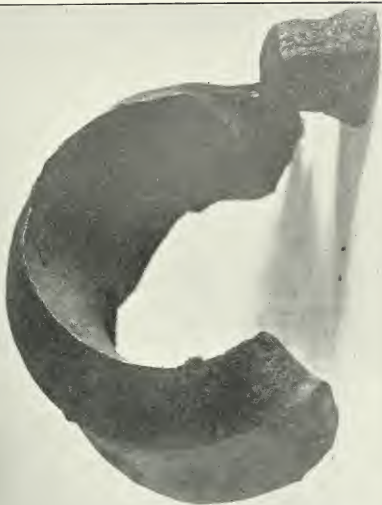
#16

16. Shows a fragment of $\frac{3}{4}$ " plate torn, sheared and bent.
